INDUSTRIAL FIELD REPORT

SEWAGE WATER CLEANING - TANKS

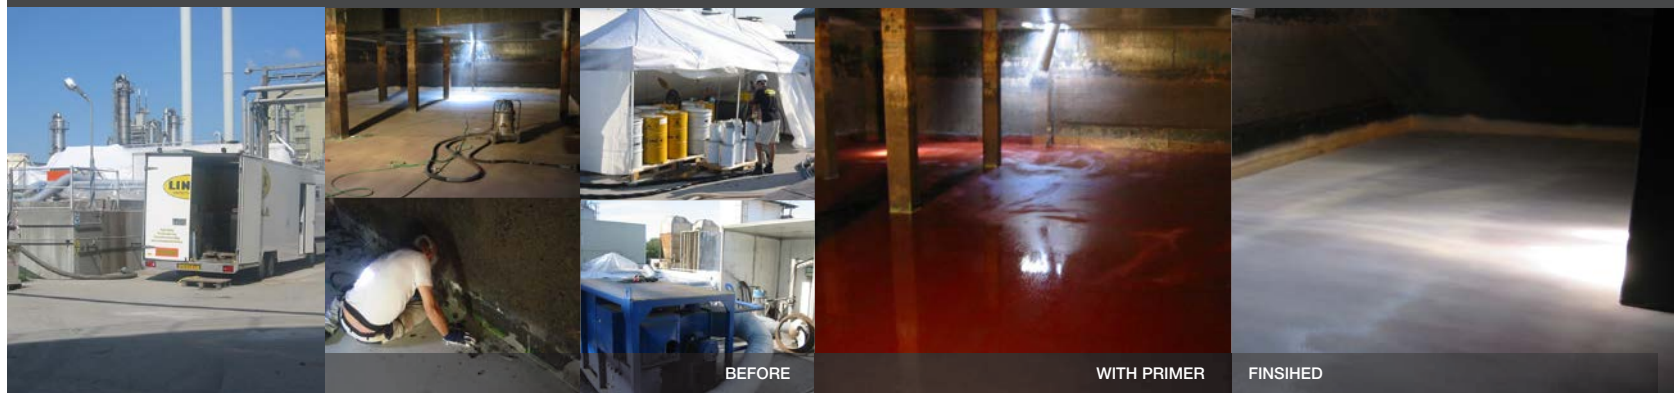
CP Kelco is a global producer of hydrocolloids. At the facility in Denmark they needed the floor of 2 sewage water tanks on 450 m² each to be recoated.

LINE-X[®] XS-350 was sprayed 3.18 mm (1/8 inch) thick onto primed concrete creating a monolithic, impervious protective lining with tenacious adhesion. The difference in thickness was less than 4 % calculated over all 900 m² thanks to our skilled applicators.

Each tank was completed in one week and back in service 12 hours after application.
